The April 22, 1991 Limón (Costa Rica) earthquake

G. Santana

Laboratorio de Ingeniería Sísmica, Universidad de Costa Rica, Costa Rica

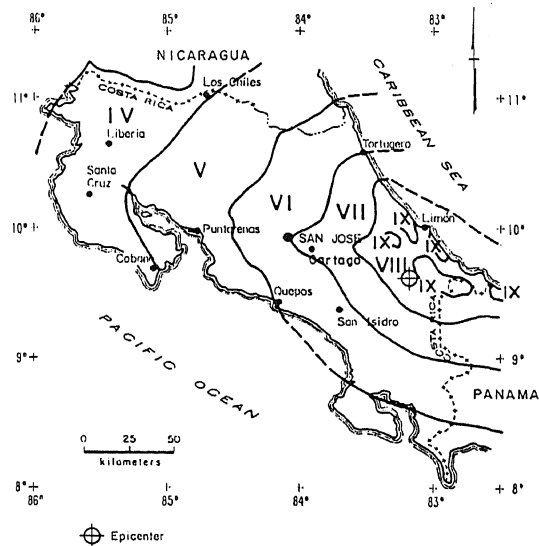
Fig 1. MM intensities of the 1991 main shock (after Rojas, 1991).

The maximum MM intensity was IX in Matina, just north of Highway 32, along Highway 36 on the coast south of Limón and in Panama next to Costa Rica (fig 1).

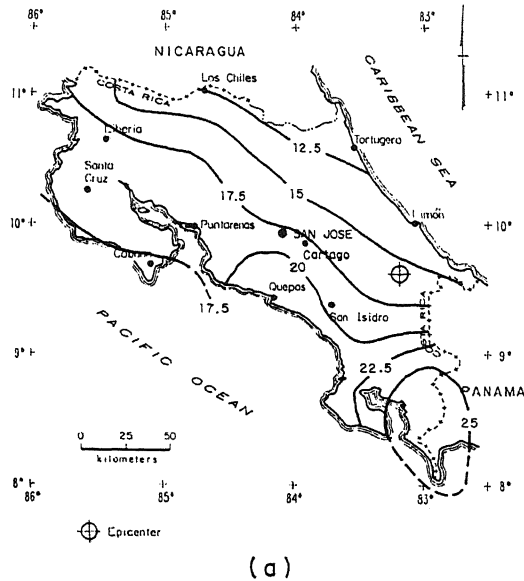
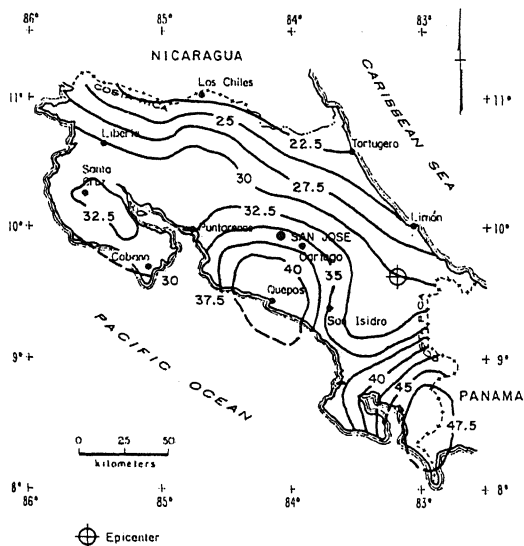
The 1986 Seismic Code (Código Sísmico de Costa Rica) uses isoacceleration maps, based on Mortgat et al (1977), for return periods of 50, 100 (fig 2a), 500 and 1000 (fig 2b) yr. The latter reflects the assumption of three source zones, all near the Pacific coast. Santana (1990) gives examples of damage from a recent earthquake with epicenter in Nicoya Gulf off the Pacific coast. Yet the April 22, 1991 event occurred near the Caribbean coast, far from the assumed source zones.

Fig 2. Code isoacceleration curves for a) 100 yr return period; b) 1000 yr return period.

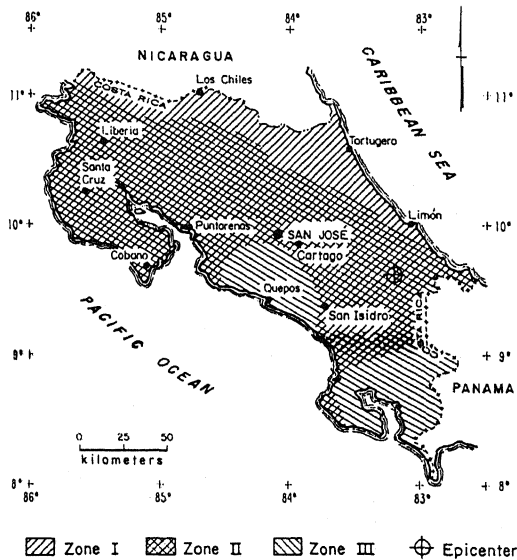
The code requires modal analysis for structures taller than 30 m and allows static analysis for lower structures. In both methods the peak acceleration is obtained from the isoacceleration maps. For 1-2 story buildings a simpler approach is permitted; the country is divided into three zones (fig 3); base shear coefficients are 0.11, 0.22 and 0.33 for zones I, II and III, respectively.

Fig 3. Code seismic zones for simplified design.

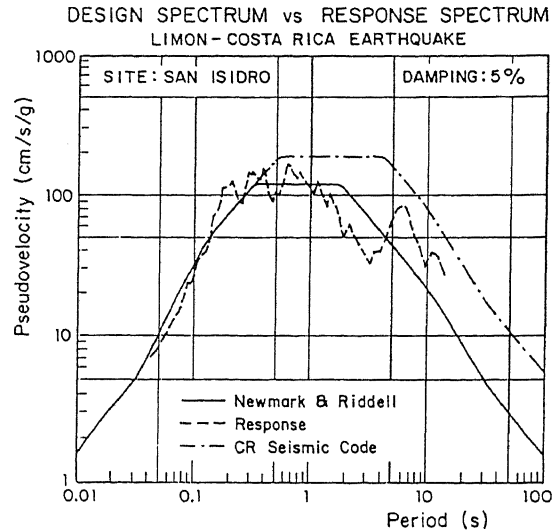
At San Isidro the strong shaking (5-95% of the Arias intensity) lasted 26.2 s, much longer than at Presidio during the 1989 Loma Prieta earthquake and in the 1986 San Salvador earthquake. Comparison of the 5%-damping response spectrum for the strongest San Isidro component with the code design spectrum and with that derived from the Newmark-Riddell criteria (fig 4) shows that the latter spectrum is in reasonable accord with the response spectrum but that the code overestimates spectral ordinates for long periods. This is more pronounced for the Cartago station, on soft ground (fig 5). As a consequence structures with long fundamental period, designed according to the code, are overdesigned, especially on soft ground. The situation is brought out in fig 6, which shows ductility demands for single-degree-of-freedom systems designed for a ductility factor of 4. Qualitatively the same holds for other design ductility factors. (The apparently excessive demand in very rigid structures is doubtless covered by their overstrength. — Note by the editor.) This helps explain the low-damage incidence to large buildings in San José's metropolitan area.

Fig 4. Response and design spectra, San Isidro Station.

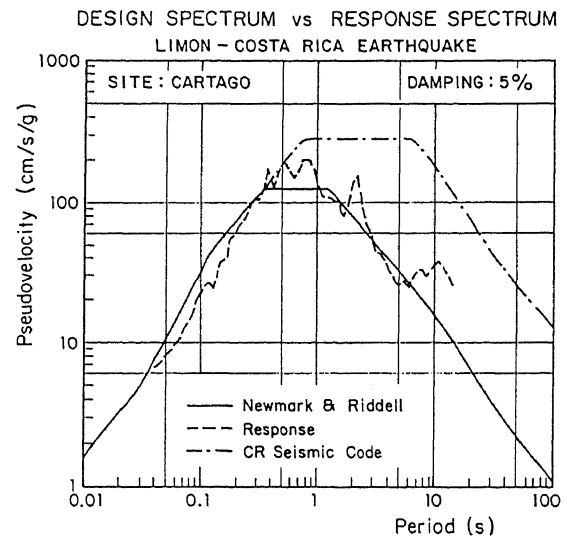
Fig 5. Response and design spectra, Cartago Station.

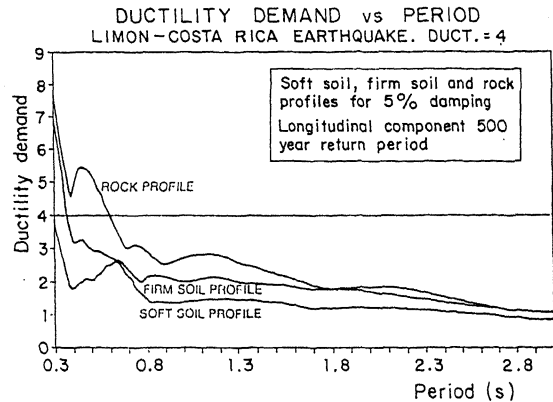
Fig 6. Ductility demands in a single-degree system designed for ductility factor of 4 according to the code.
