# METHODOLOGY TO ANALYZE THE DEGRADATION OF STRUCTURAL TIMBER IN ACIDIC ATMOSPHERES

Viviana Paniagua-Hernández<sup>1</sup>, Cindy Torres<sup>2</sup>, Beatriz González-Rodrigo<sup>3</sup>, Zuhra Sasa<sup>1</sup>

1)Architecture Dept, UCR viviana.paniaguahernandez@ucr.acr  
3)Civil Engineering School. UPM Spain.

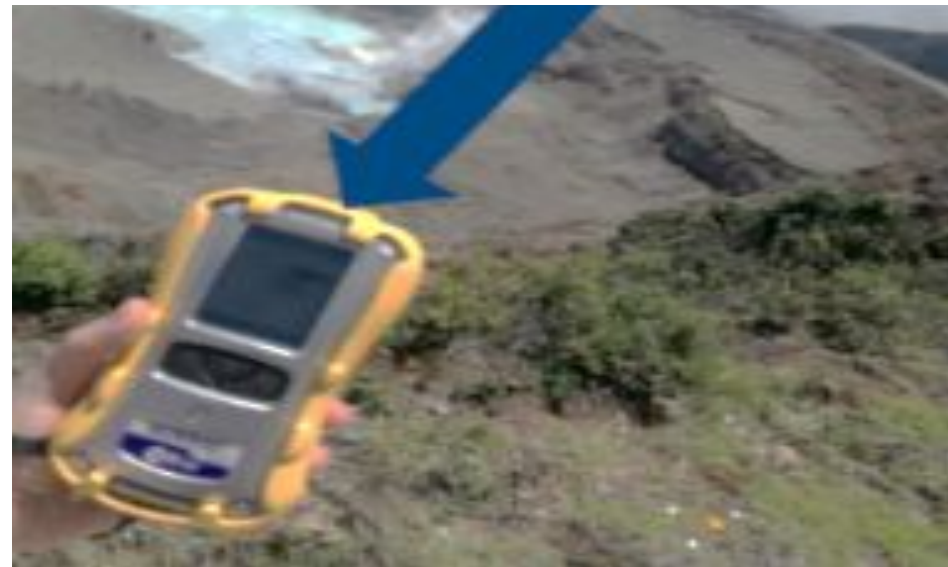
Figure 3: Multirae SO<sub>2</sub> gas detectors.

**Environmental acidity** Acidic atmosphere was characterized considering the weather parameters, acidity of rain (placing fog and rain collectors) Sulphur gases SO<sub>2</sub> and H<sub>2</sub>S detection measured through constant monitoring.

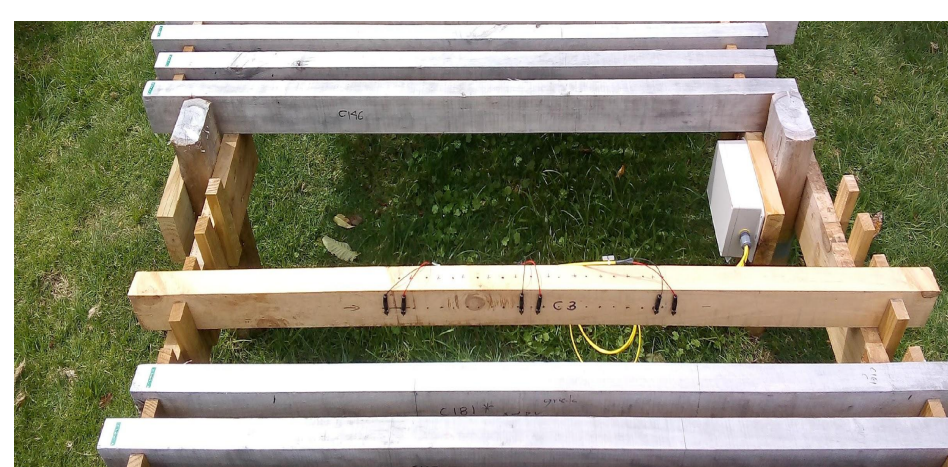
Figure 5: Sensor monitoring on-site

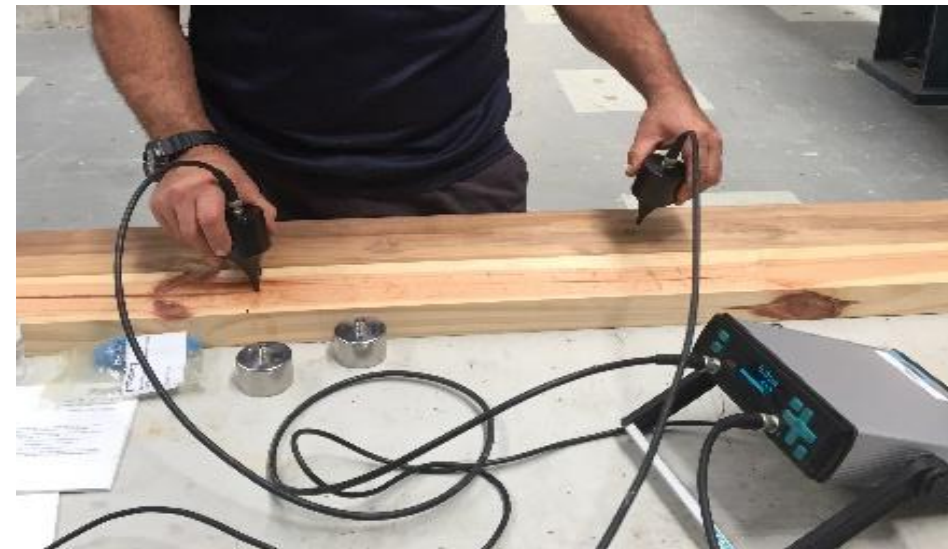
Figure 6: Ultrasound test NDT.

B) Macroscopic changes measured on mechanical properties. Combining: Non destructive technique Ultrasound test and bending test to obtain dynamic and static elasticity modulus E<sub>dyn</sub> and E<sub>st</sub> respectively. Before laboratory tests specimens were acclimatized in a room with controlled conditions to obtain best performance. Young modulus and chemical composition changes are the response variables.

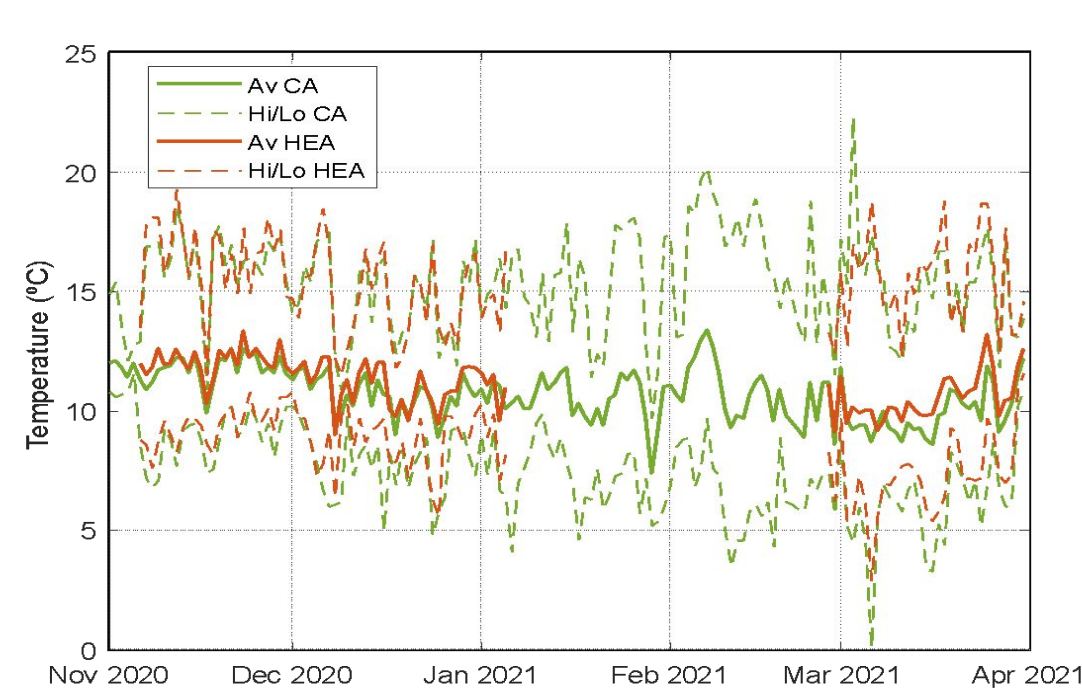
Figure 10: Temperature profile in HEA

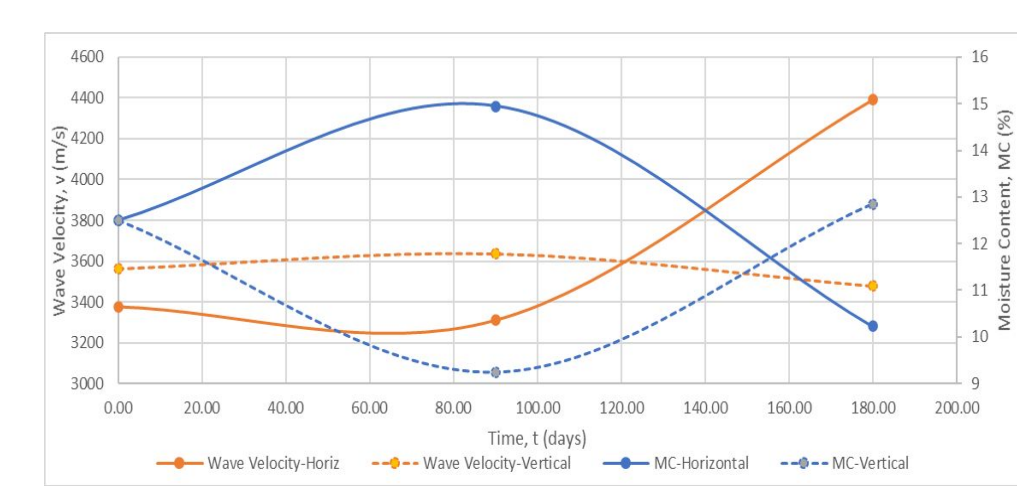
Figure 11: MC, Wave Velocity HEA 6months

An estimated decline rate of 5-7% in E<sub>dyn</sub> and 8-11% in E<sub>app</sub> was found. A tendency of 3% more decrease in Cypress than in Teak was documented. The ultrasonic wave velocity and E<sub>dyn</sub> were sensitive to environmental conditions, and changed as a function of species and exposure time. Even though the reduction in the elastic modulus is appreciable in both species, Teak is more resistant to the environment than the softwood, Cypress, unless so far this report had been carried out. Therefore, the degradation impact shall be more noticeable in three years to comply with this methodology.

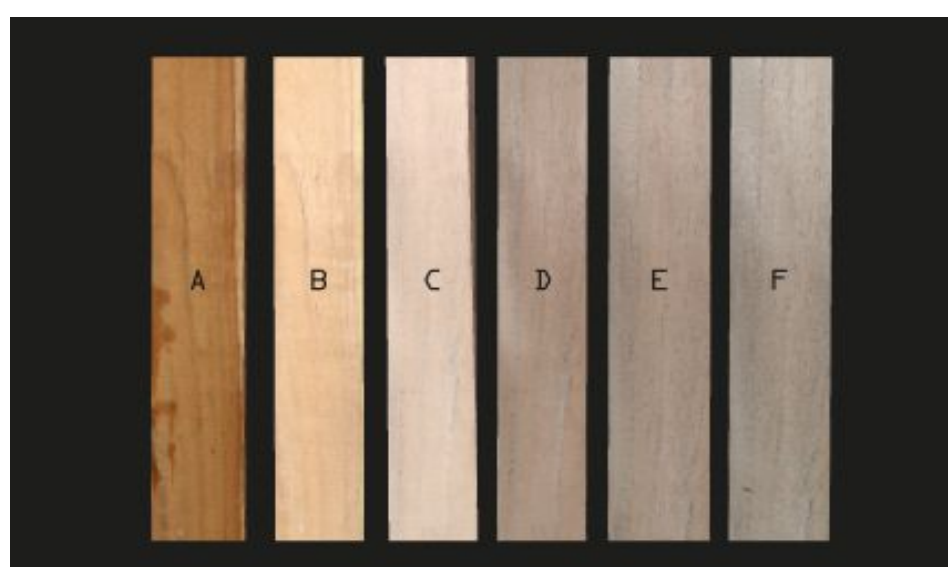
Figure 12: Color changes CIE Lab

1) **On-site analysis**, ultrasound wave velocity and colorimetric changes (CIELab system)

Significant modification of color on average ΔE 12.67 for Cypress and ΔE 17.24 for Teak were registered; further analysis is required to understand the correlation of color changes with other factors.

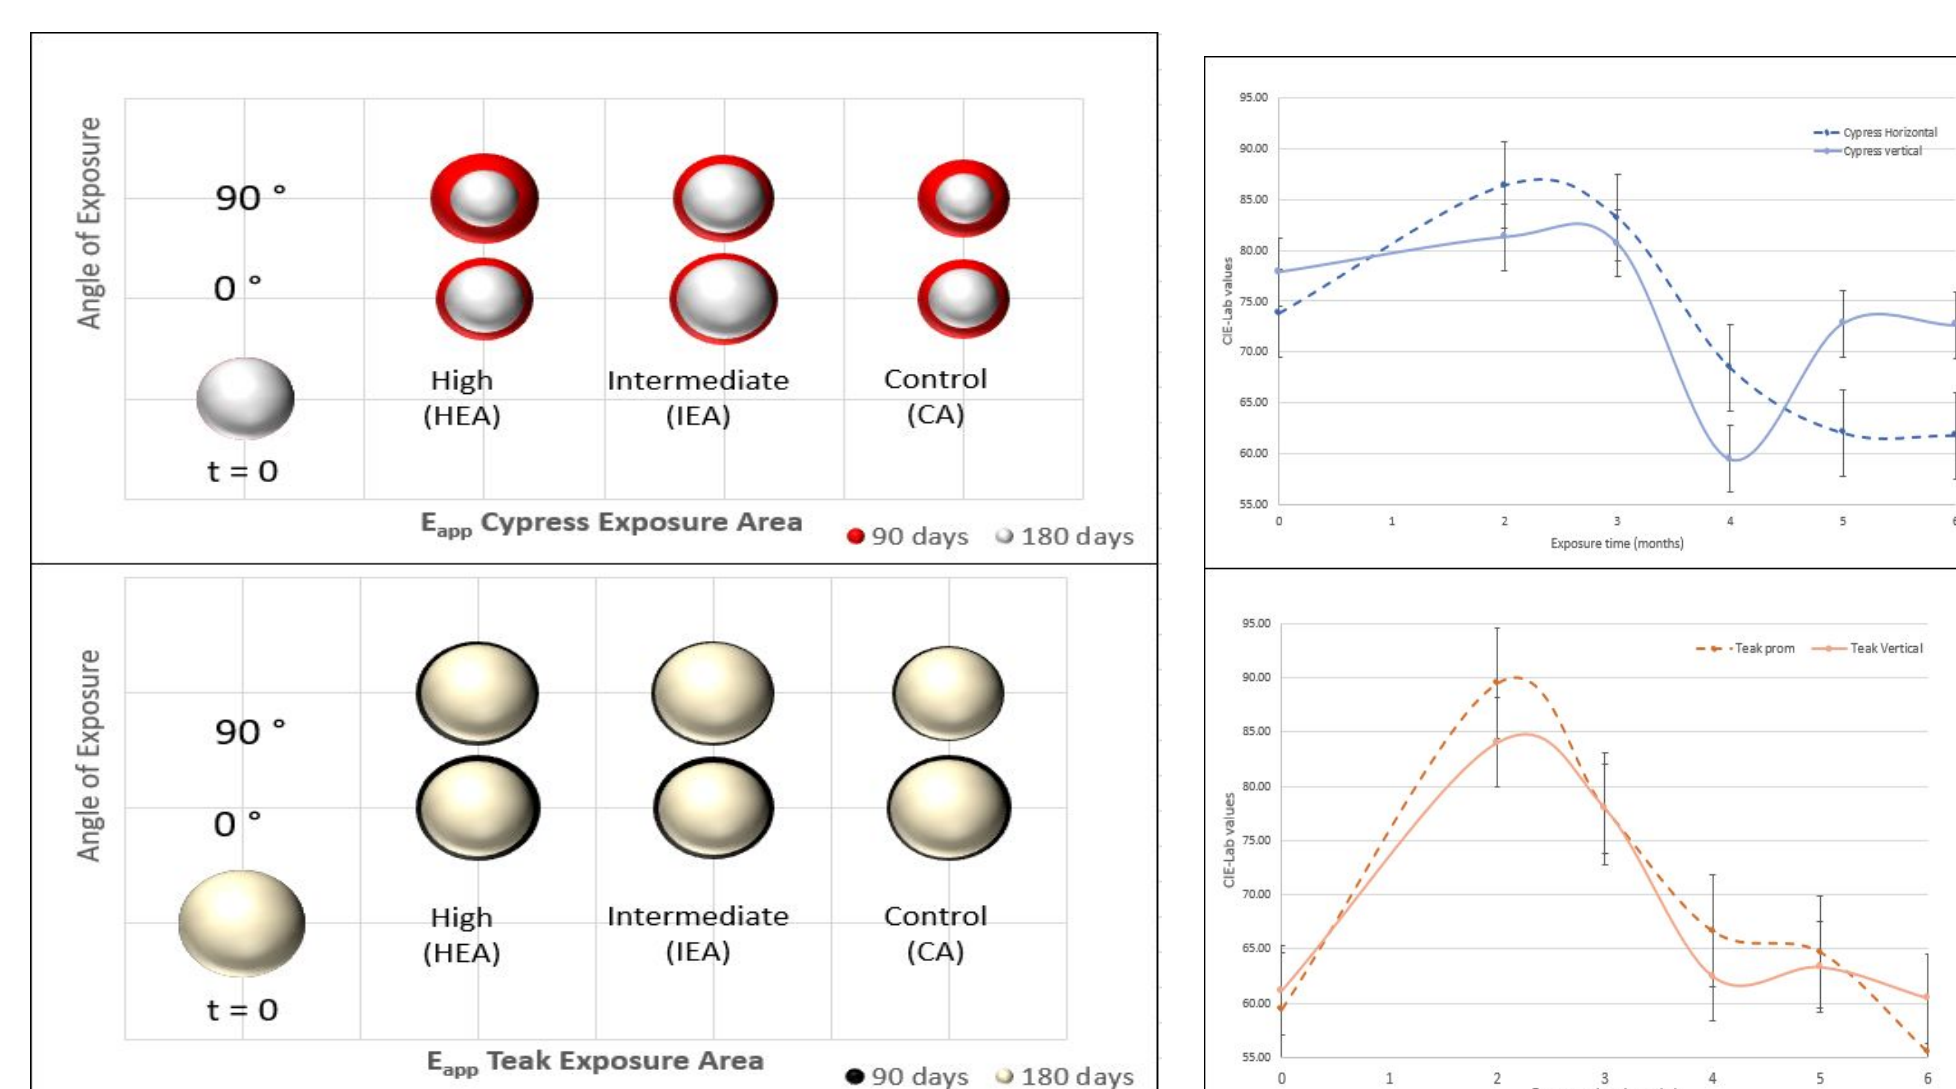
Figure 13. Cypress E<sub>app</sub> and E<sub>dyn</sub> decreased during 180 day of exposure CIE-Lab color 6 month of exposure Teak (left) and Cypress (right).

Initial parameters were E<sub>app</sub> 11.17± 0.67GPa for Cypress, and 14.78± 0.79 GPa for Teak; and E<sub>dyn</sub> 10.21± 0.34 GPa for Cypress and 15.88±0.55 GPa for Teak. For both species, an appreciable decreasing in the E<sub>app</sub>, and E<sub>dyn</sub> values at 90 days and then at 180 days was observed. Cypress E<sub>dyn</sub> decreased in average 2.2±0.68 GPa and 2.1±0.31 GPa for Teak. For both species, an appreciable decreasing in the E<sub>app</sub>, and E<sub>dyn</sub> values at 90 days and then at 180 days was observed. Cypress E<sub>dyn</sub> decreased in average 2.2±0.68 GPa and 2.1±0.31 GPa for Teak.
